**netX500, Revision A (Step A, ROM Rev. 0, Boot loader major vers. 0x41)**

### C. Errata Summary

## D. Errata Details:

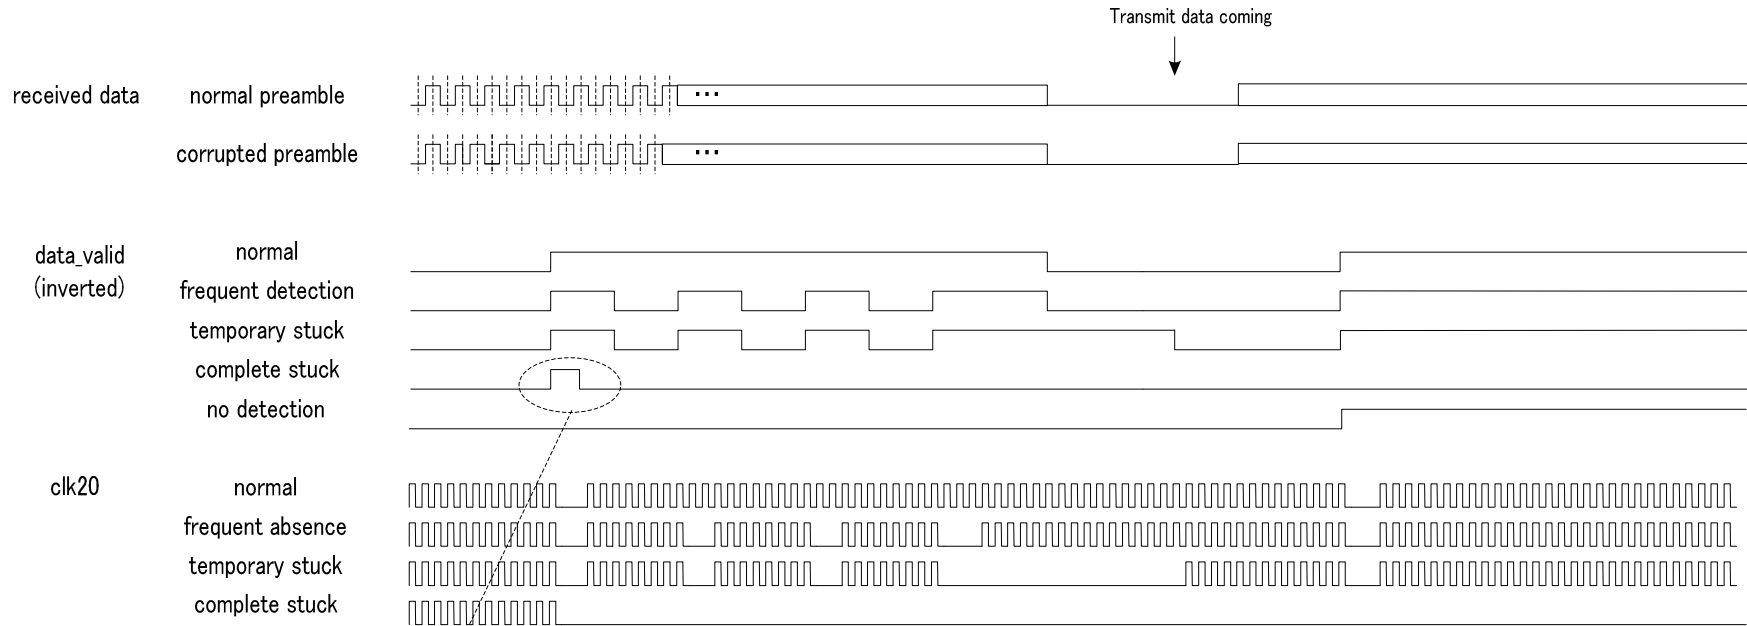
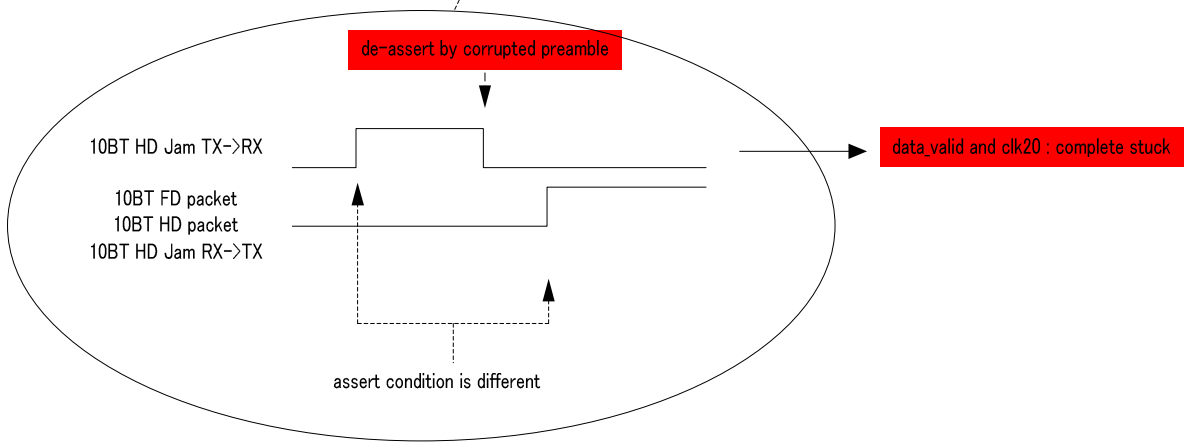
# term and condition on previous page

- Illegal behaviour of COL signal during 10baseT half duplex collision
  - RX immediately follows to start TX
- PHY get stuck while in 10BaseT
  - Statistical behaviour
  - Depending on IPG

The problem doesn't occur as long as one preamble is detected during all preamble pattern(56BT).
